**Power Quality
Monitors
and
Stray Voltage
Investigations**

Using a power disturbance analyzer on stray voltage investigations

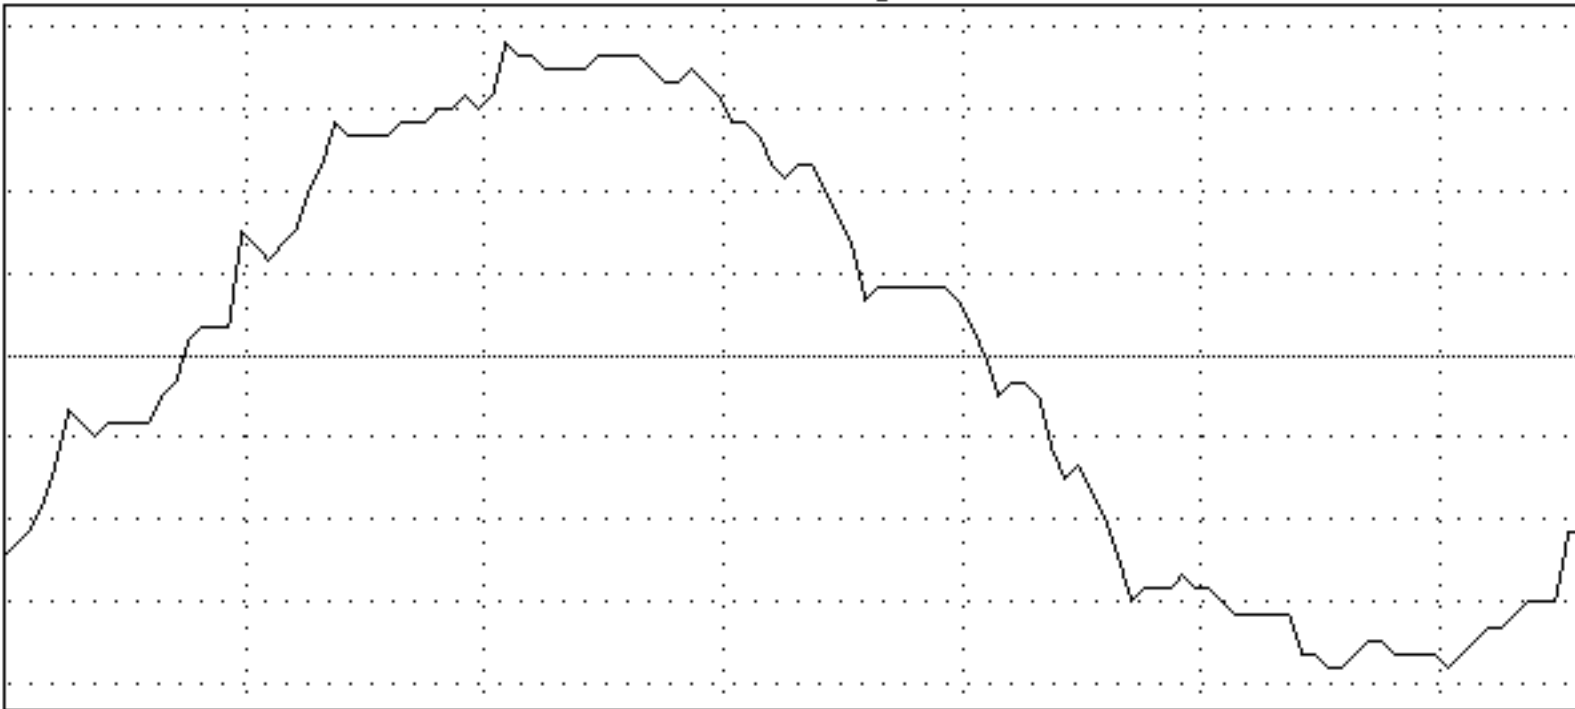
Severely distorted voltage or current wave form?.. Or an operator error?

Horizontal 2500 microseconds/division Vertical .05 Amps/division
Arms: Prev=.1309, Min=.1299, Max=.1299 - Worst Imp= 0 Apk, 0 deg
